# DUBAI SWORO CASE STUDY

The **Doha SWRO Plant** produces 125,000 m<sup>3</sup>/day of desalted water. The project consists on generating 1 MGD desalinated water and 5MW of energy power generation. Facilities include diesel power generation plant and power distribution, Reverse Osmosis desalination plant and a transmission pipeline to Doha, seawater intake structure, water tower, control buildings, laboratories, office/administration building, mosque and housing facilities.

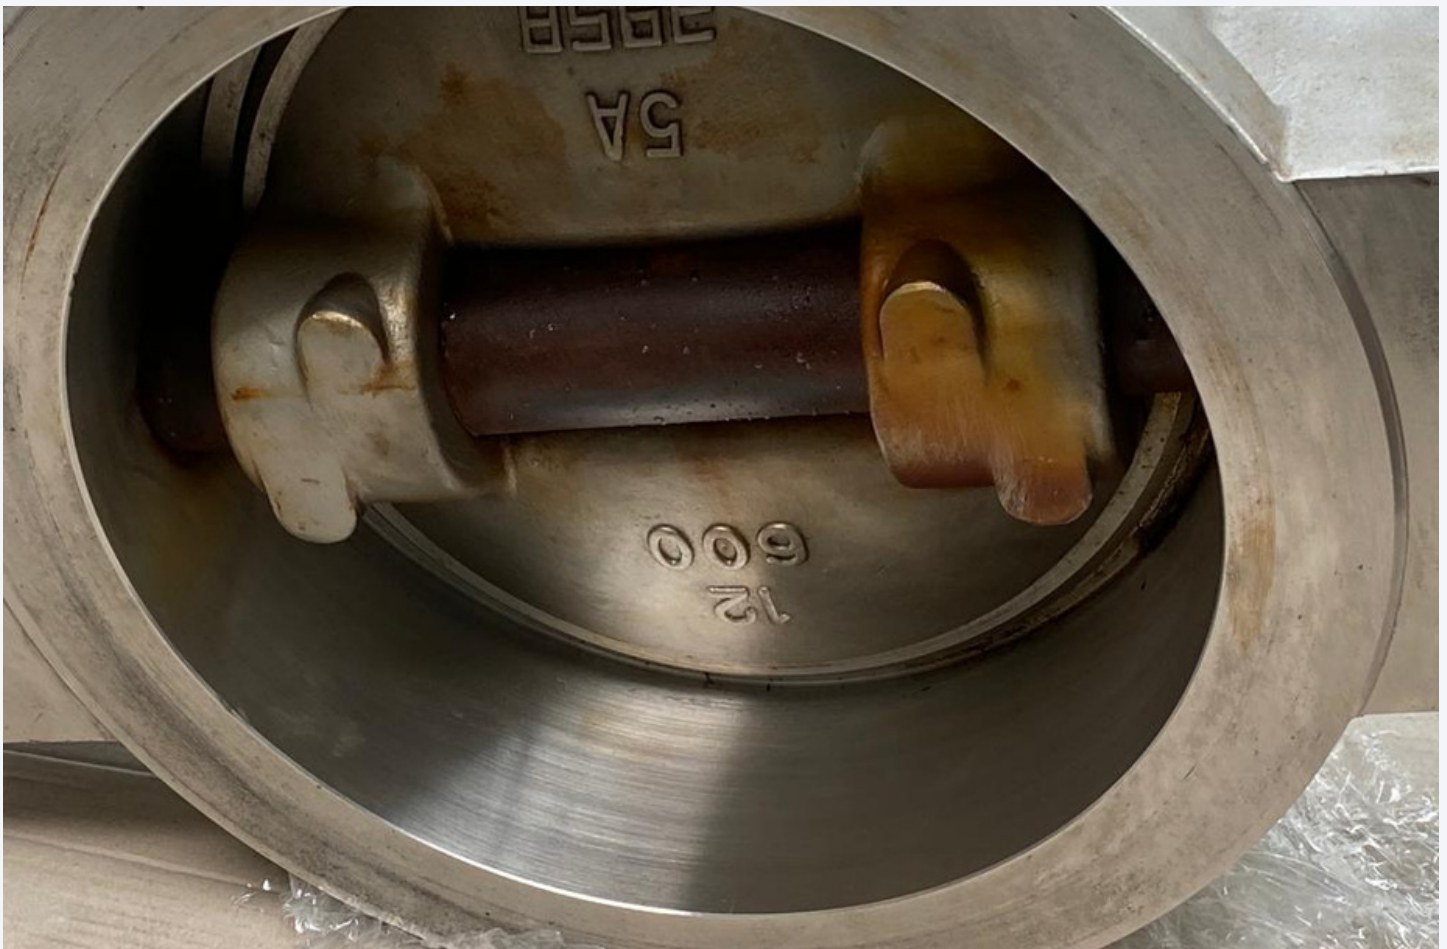
- **valveIT Technical Staff**, basing on its previous experience on desalination project and evaluating chemical and technical data coming from the client, came to the problem potential cause by noting the **circular border** of the corrosion track. As shown by the provided photo, the problem referred to valve parts which were not in contact with high-corrosive fluids flowing inside the plant's pipes: **galvanic corrosion** didn't affected the valve internal super duplex disc and parts.

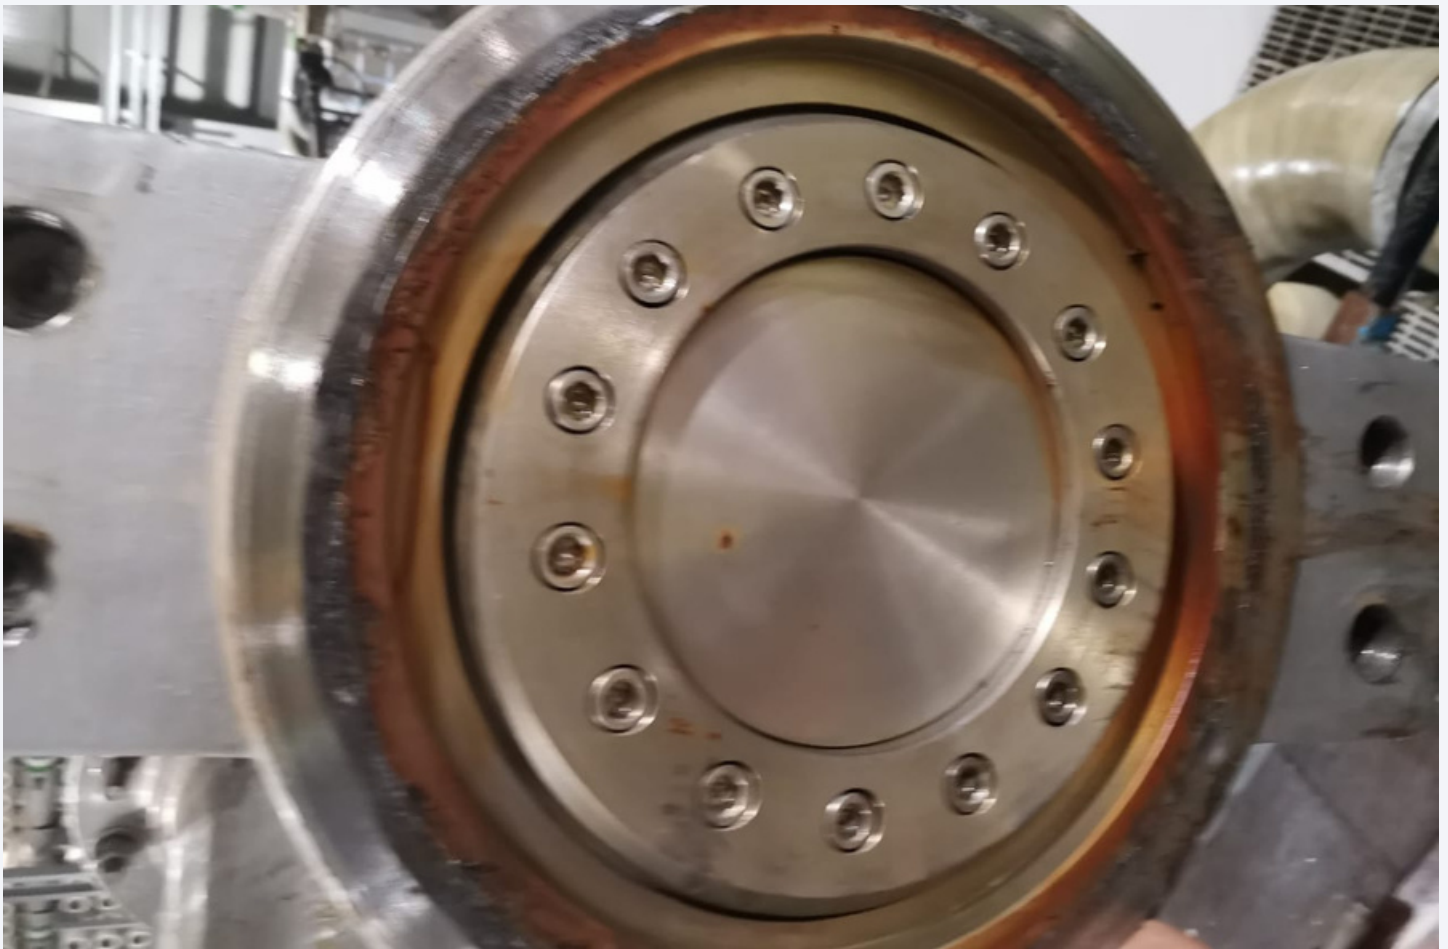
- Due to the presence of the gasket's graphite winding, the chemical corrosion had been ascribed by valveIT to the **different electrochemical material behaviour** of the super duplex valve and the gasket's graphite winding. To summarize, there had been significant **crevice corrosion** failures of the super-duplex stainless steel valves associated with graphite gaskets: these failures usually happen in chlorinated systems for which the corrosion potentials are particularly high and beyond the range for which a benefit from graphite could be anticipated.

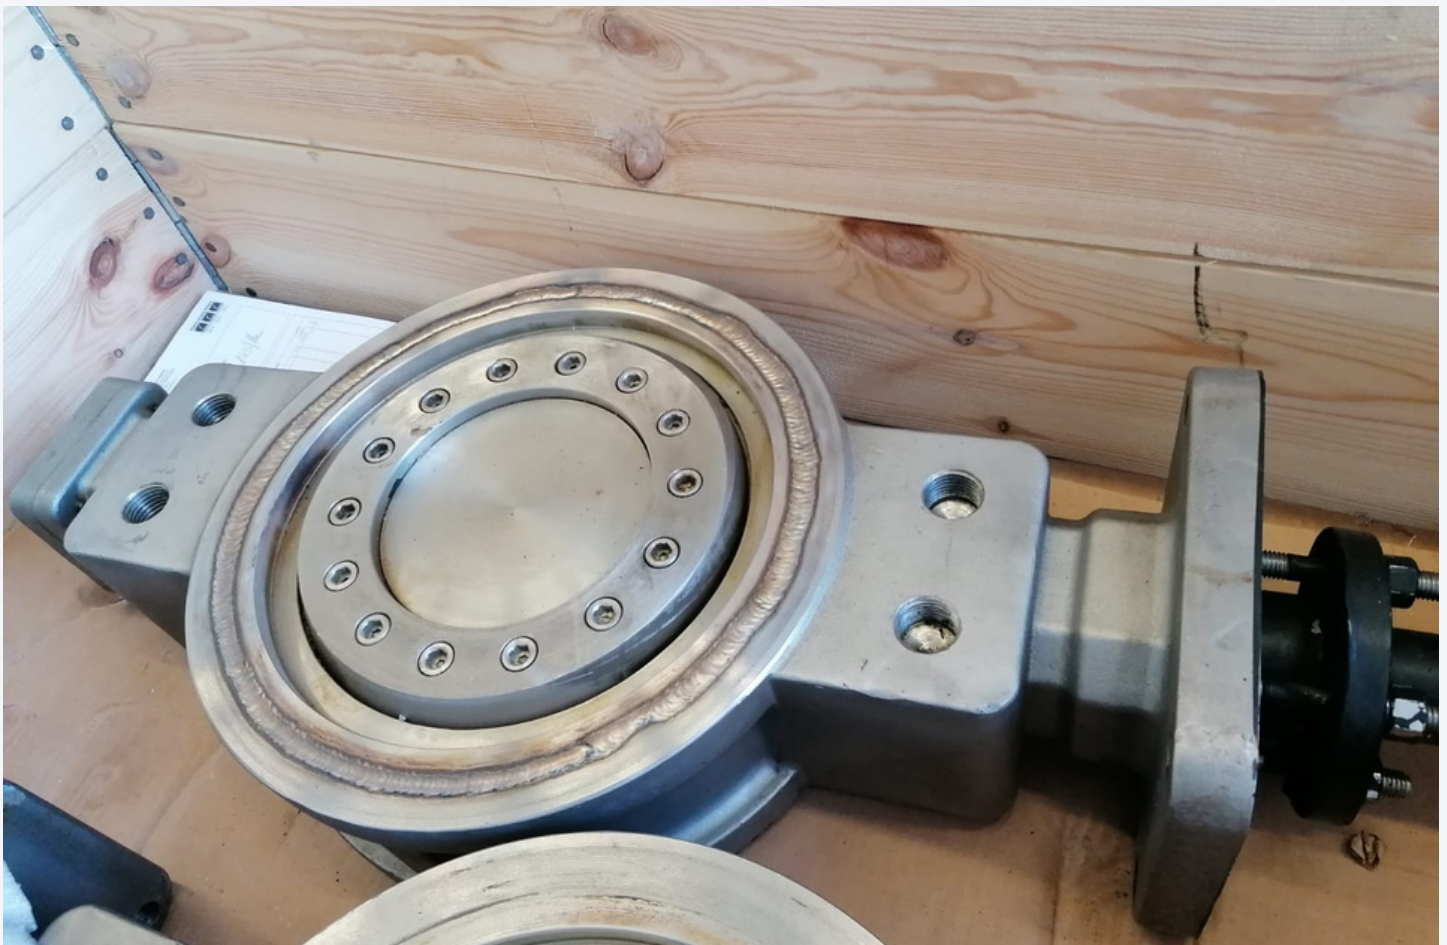
- The material reaction happening on the **low-pressure valve side** connected to the gasket was caused by the fact that high chlorinated seawater passed through the gasket's inner ring and touched the graphite spiral wound creating galvanic corrosion.[1]

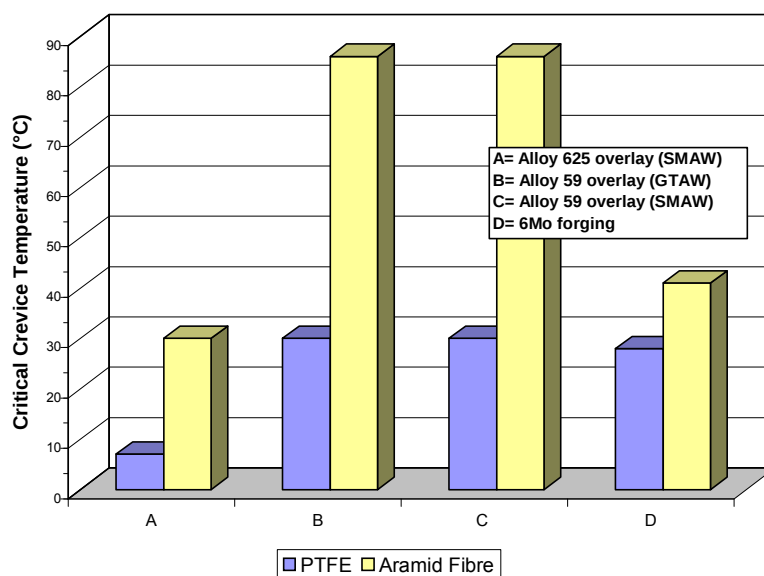
Following a series of failures of 6% Mo stainless steel flanges in the North Sea, Rogne et al<sup>6</sup> examined some weld overlays for 6% Mo to improve the resistance to crevice corrosion resistance. At the same time they examined two gasket materials, PTFE and aramid fibre. The tests were carried out at +600mV SCE, simulating that in chlorinated seawater, and the threshold temperatures for crevice corrosion were determined. The results are summarised in Figure 1. The results show that PTFE creates a much more severe crevice than aramid fibre, particularly for the nickel alloys. It is interesting that an alloy 625 (UNS N06625) weld overlay was inferior to a wrought 6% Mo flange with the same gasket material. This demonstrates that a material with a high resistance to crevice corrosion as a wrought alloy may not necessarily confer equivalent resistance when used as a weld overlay.

**FIGURE 1 Critical crevice temperature at +600mV SCE for 6%Mo stainless steel with various gasket materials (Ref 6)**

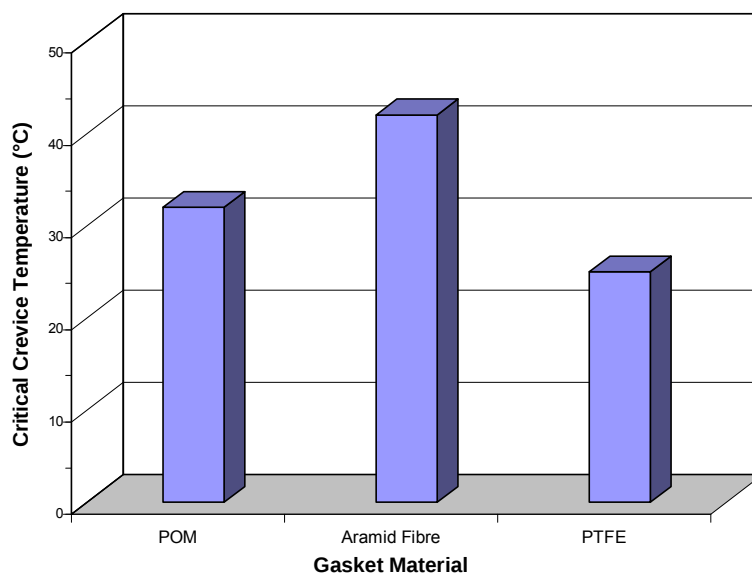
Rogne et al carried out a more extensive series of tests on 6% Mo material with a range of gasket materials<sup>7</sup>. The results, in Figure 2, show that higher critical crevice temperatures (CCT) were obtained for aramid fibre compared with both PTFE and POM. The authors showed that the gaskets giving the highest CCT values also absorbed the most water. This meant there was more water within a gasket that could diffuse into the tightest regions to delay the onset of crevice corrosion. In addition, materials such as PTFE can deform to fit the flange face, creating tighter crevices.

**FIGURE 2 Critical crevice temperature at +600mV SCE for 6%Mo stainless steel with different gasket materials (Ref 7)**

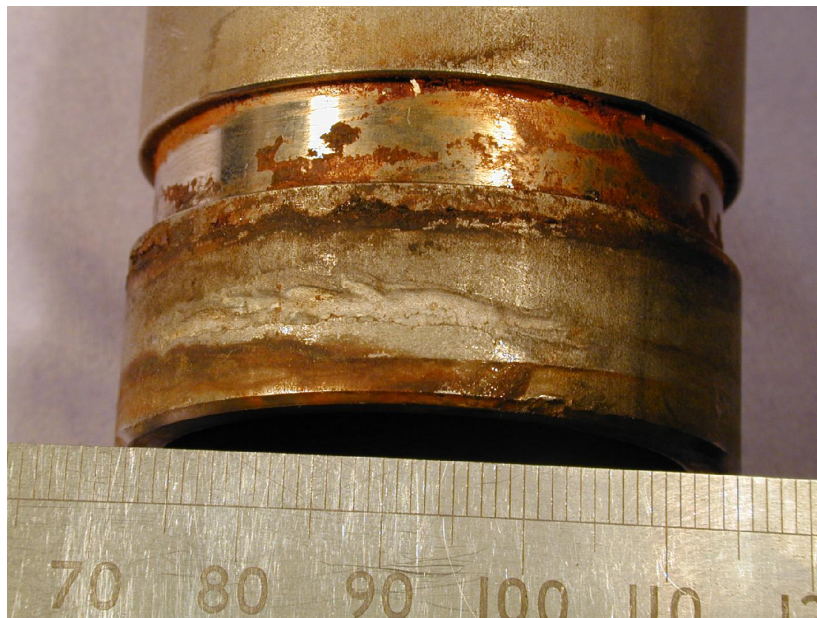
FIGURE 4 - Crevice corrosion of 316L at high pressure pipe joint.

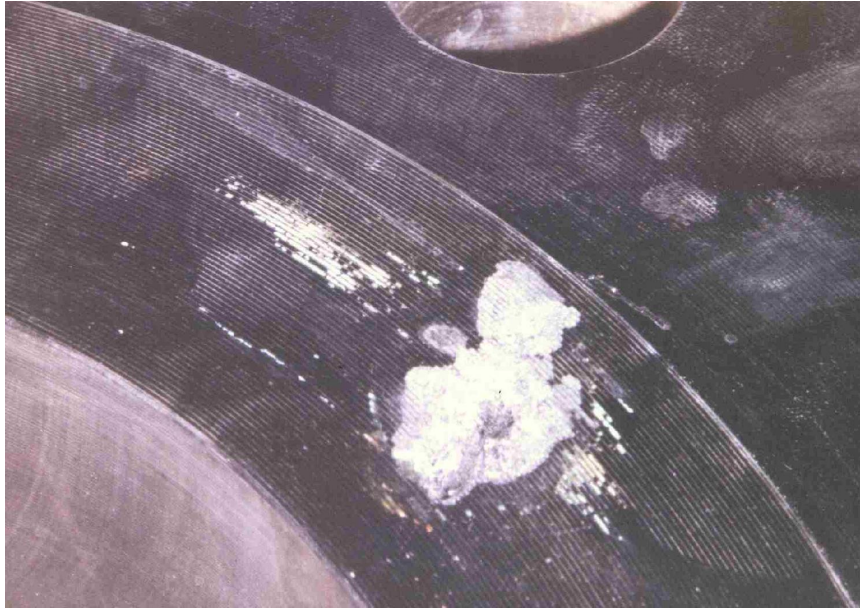
seen the problem in superduplex flanges on the seawater feed piping at an RO desalination plant in the Middle East. Figure 5 shows the typical appearance of the attack.

FIGURE 5 - Corrosion of a superduplex flange with a graphite-containing gasket.

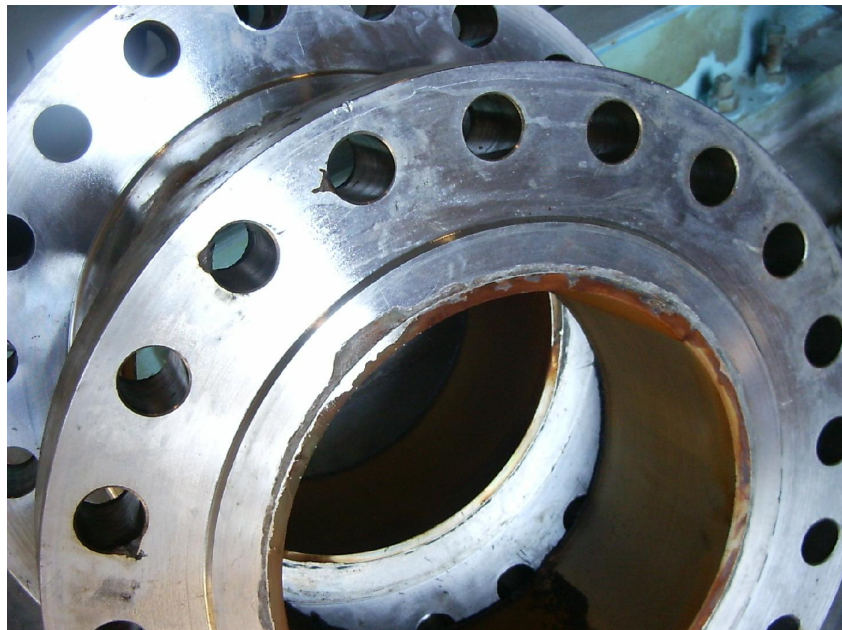
PTFE has not often been used for gaskets in seawater systems and reported cases of failures are rare. Figure 6 shows corrosion of a superduplex stainless steel flange from on RO desalination plant where PTFE had been used. In this case, the gasket was a 316L spiral wound gasket coated in PTFE, because the joint was in the high pressure section (70 bar). A change was made to a compatible metal gasket with no coating.

FIGURE 6 - Corrosion of a superduplex flange with a PTFE coated gasket.

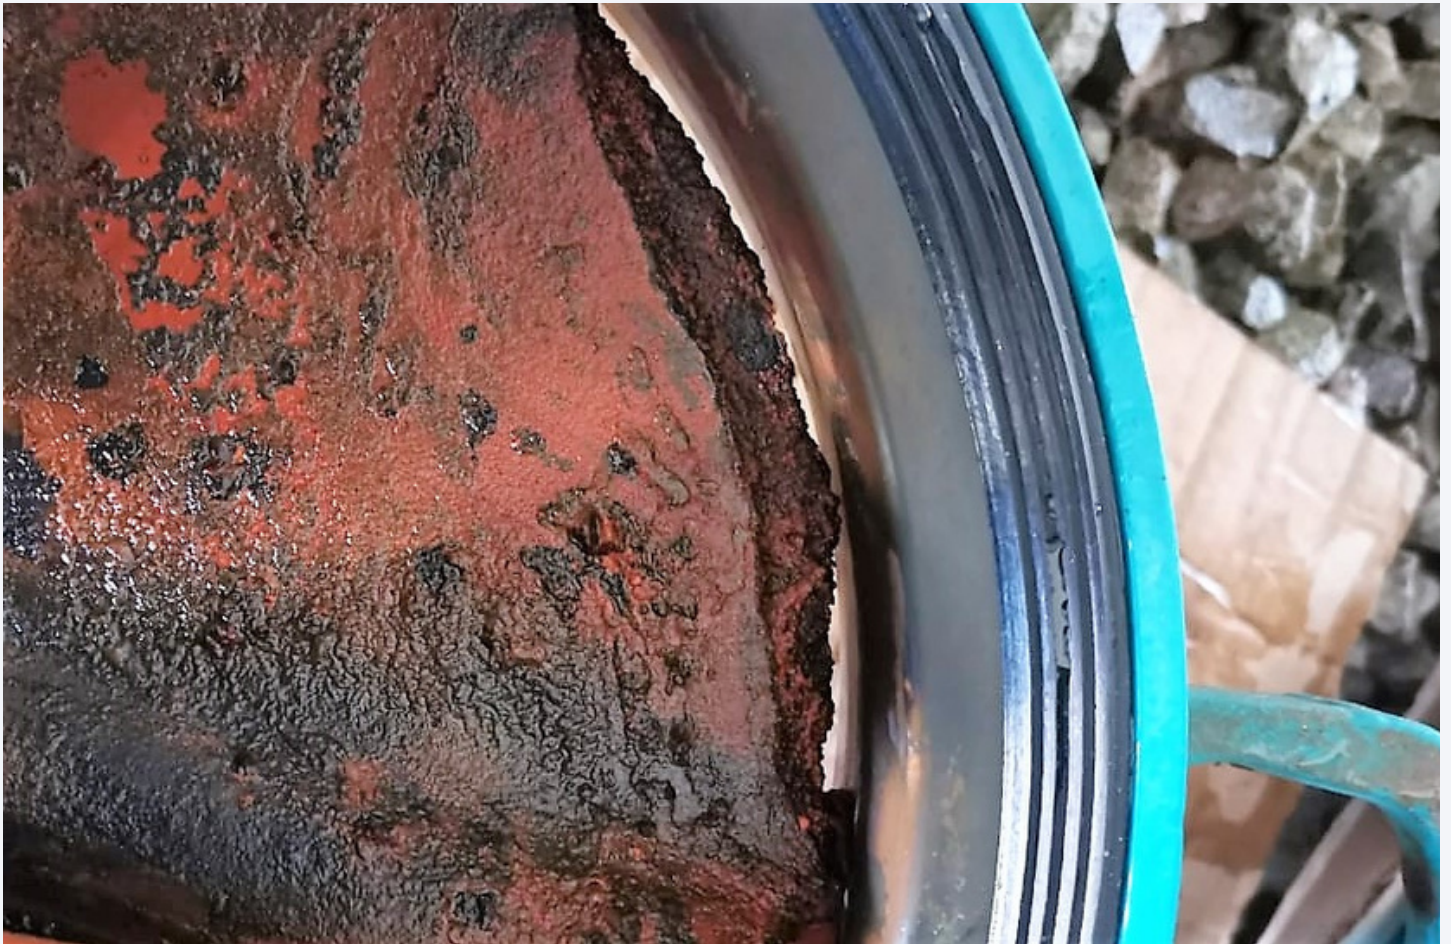
- Valve discs suffered from high level of corrosion due to the really hard environment of the Dhuba desalination Plant. Salt, Sand, Humidity, Wind & Sun strongly affected different kind of instrumentation applied on this plant.
