# DUBAI SWORO CASE STUDY

The **Doha SWRO Plant** produces 125,000 m<sup>3</sup>/day of desalted water. The project consists on generating 1 MGD desalinated water and 5MW of energy power generation. Facilities include diesel power generation plant and power distribution, Reverse Osmosis desalination plant and a transmission pipeline to Doha, seawater intake structure, water tower, control buildings, laboratories, office/administration building, mosque and housing facilities.

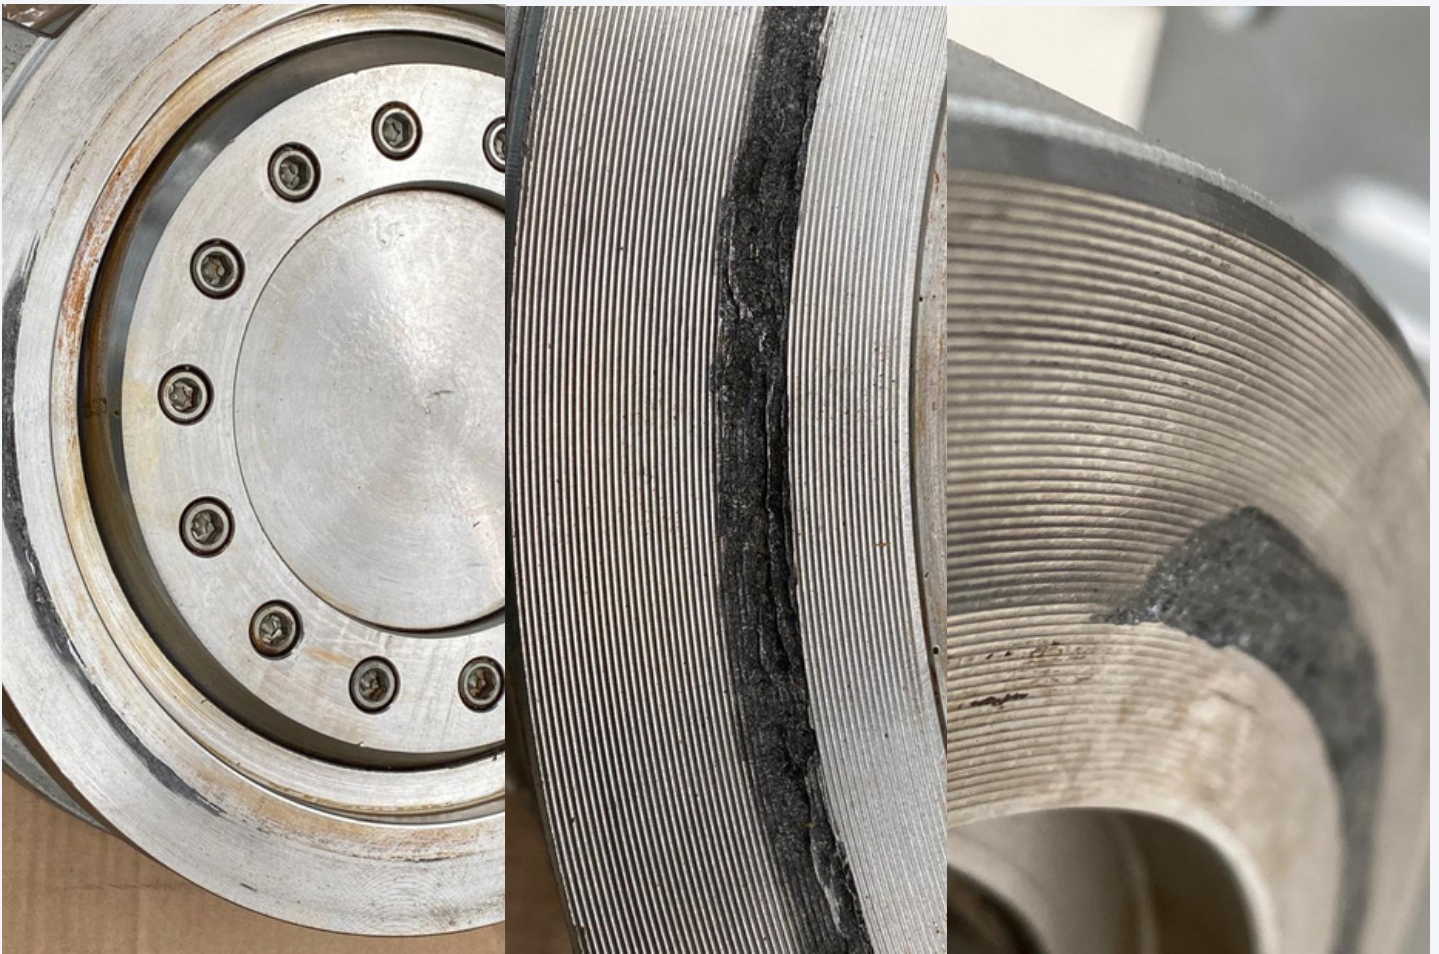
The client asked for **valveiT support** concerning problems occurred on super duplex pneumatic butterfly valves. In details, damages referred to:

- **Unusual corrosion** occurring on **internal valve sides** of the valveiT's super duplex pneumatic butterfly valves. Although the high-corrosive environment of the desalination plant, valveiT super duplex valves were built to face against this critical condition thanks to the specific use and chemical properties of the manufacturing valve material.

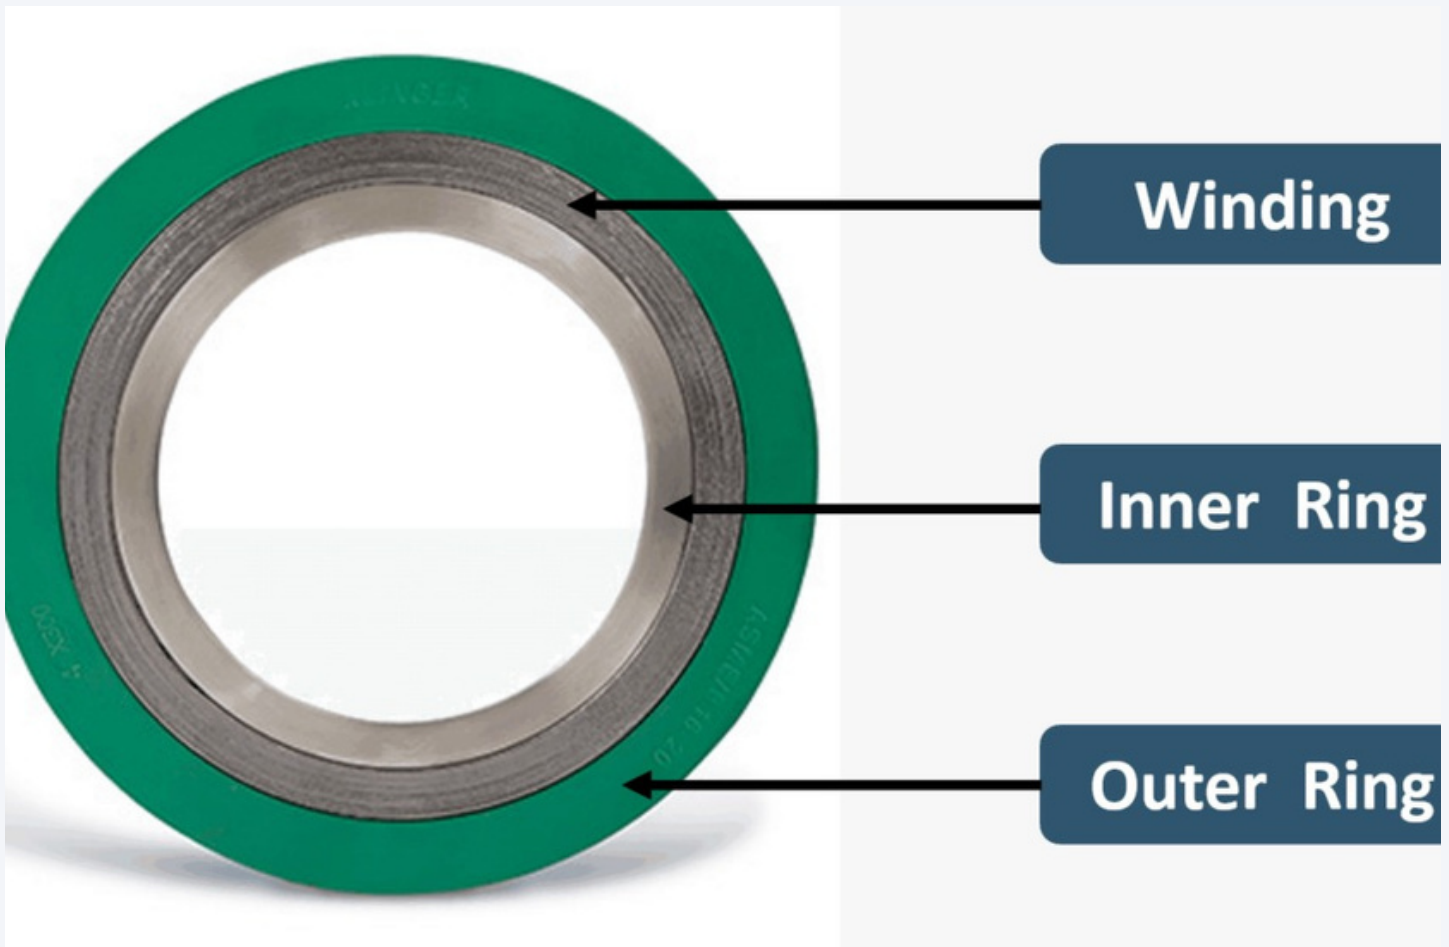
- Basing on the previous observation, valveIT asked to the client material composition of the gasket (supplied by other manufacturers) which had been installed at the Duba SWRO plant in order to guarantee the seal of the piping system. Once obtained the data, valveIT discovered that the applied gaskets were made of the following material scheme:

1. **WINDING:** Graphite
2. **OUTER RING:** Super Duplex SS32750
3. **INNER RING:** Super Duplex SS32750

- Due to the presence of the gasket's graphite winding, the chemical corrosion had been ascribed by valveIT to the **different electrochemical material behaviour** of the super duplex valve and the gasket's graphite winding. To summarize, there had been significant **crevice corrosion** failures of the super-duplex stainless steel valves associated with graphite gaskets: these failures usually happen in chlorinated systems for which the corrosion potentials are particularly high and beyond the range for which a benefit from graphite could be anticipated.

- The material reaction happening on the **low-pressure valve side** connected to the gasket was caused by the fact that high chlorinated seawater passed through the gasket's inner ring and touched the graphite spiral wound creating galvanic corrosion.[1]

1. **Grinding/polishing of the damaged surface**
2. **Grinded Surface preparation**
3. **Welding overlay Super Duplex**
4. **Machining of welded overlay**
5. **Phonographic spiral groove machining**
6. **Pressure test**

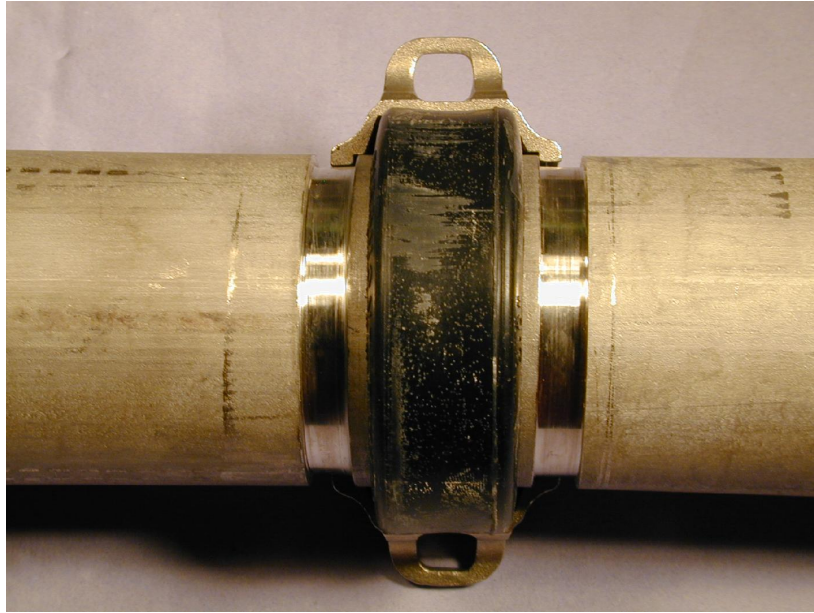
FIGURE 3 - High pressure pipe joint with one half of clamp removed.

Another method of coupling in high pressure systems is the Victaulic-type joint. In this, both pipes have a square cut groove on the outside of the pipe, some 15mm or so from the end. A rubber boot slips over both pipe ends and it is held in place with a clamp, as shown in Figure 3. The sealing boot is usually made of a synthetic rubber. The crevice created by such a seal is relatively tight and deep and it has caused corrosion of low alloy materials, such as 316L, in seawater, as shown in Figure 4<sup>12</sup>. Crevice corrosion with this type of joint and high alloy stainless steels is rare and corrosion is usually due to poor heat treatment of the stainless steel.
