## ABU QIR CASE STUDY

The **Abu Qir Fertilizer Complex** consists of:

**The client** asked for **valveIT support** concerning problems occurred on the **hard rubber lined pipes** used for abrasive fluids. In details, damages referred to:

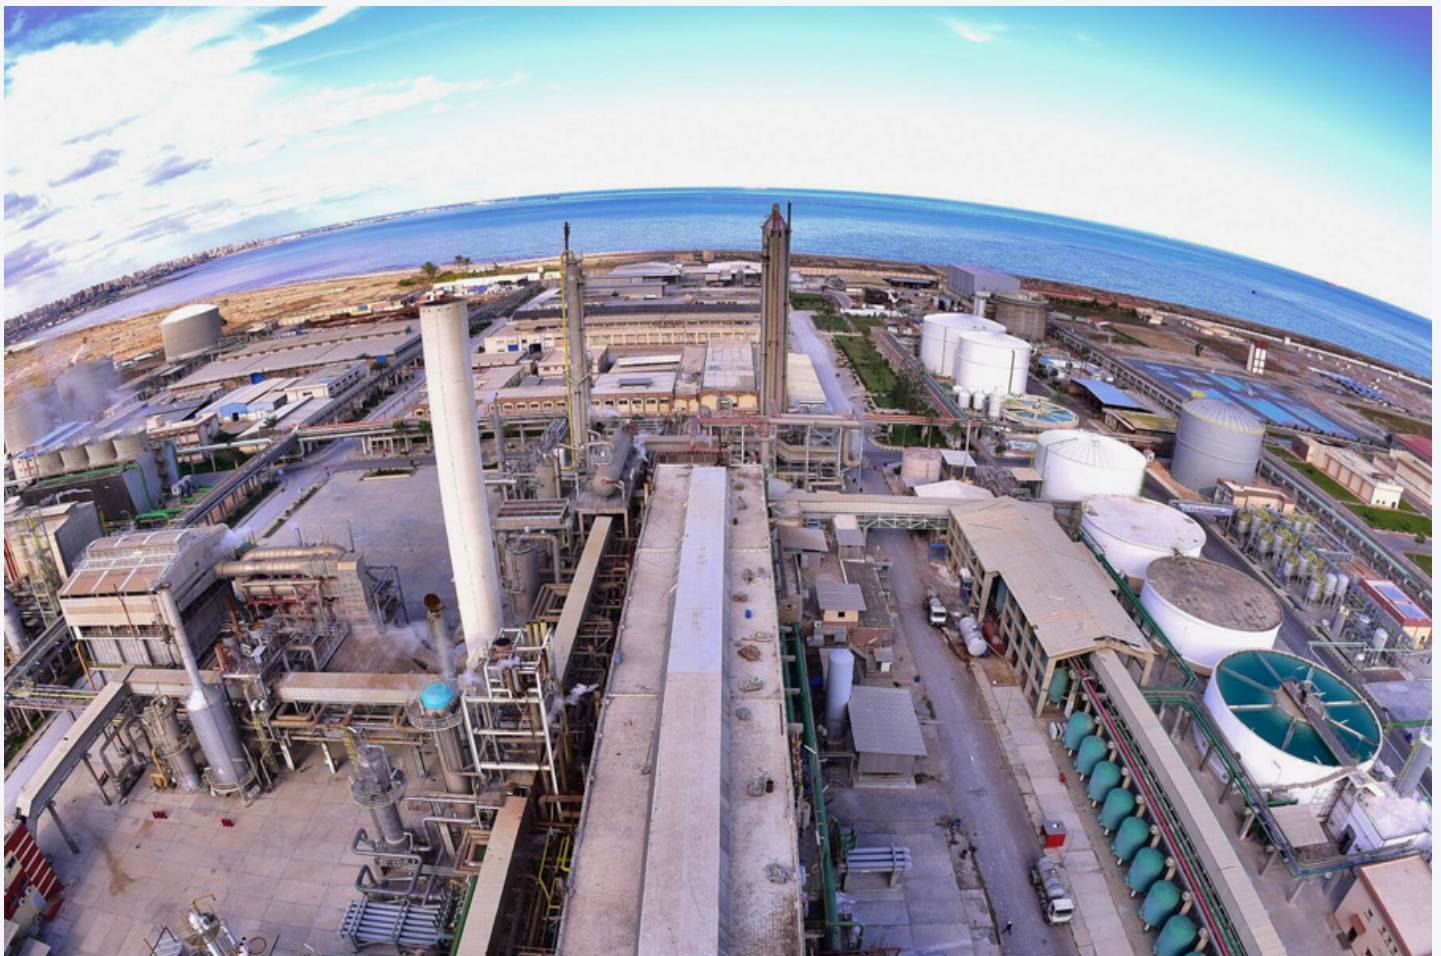
- No. 1 Ammonia Plant 1000 & No. 1 Urea Plant 1550 mtpd & No. 1 Urea Drilling Plant
  - No. 1 Ammonia Plant 1000 mtpd, No. 1 Nitric Acid Plant 1800 mtpd & No. 1 Ammonium Nitrate Granulation Plant 2400 mtpd
  - No. 1 Ammonia Plant 1200 mtpd, No. 1 Urea Plant 1750 mtpd & No. 1 Granulation Plant 2000 mtpd
-

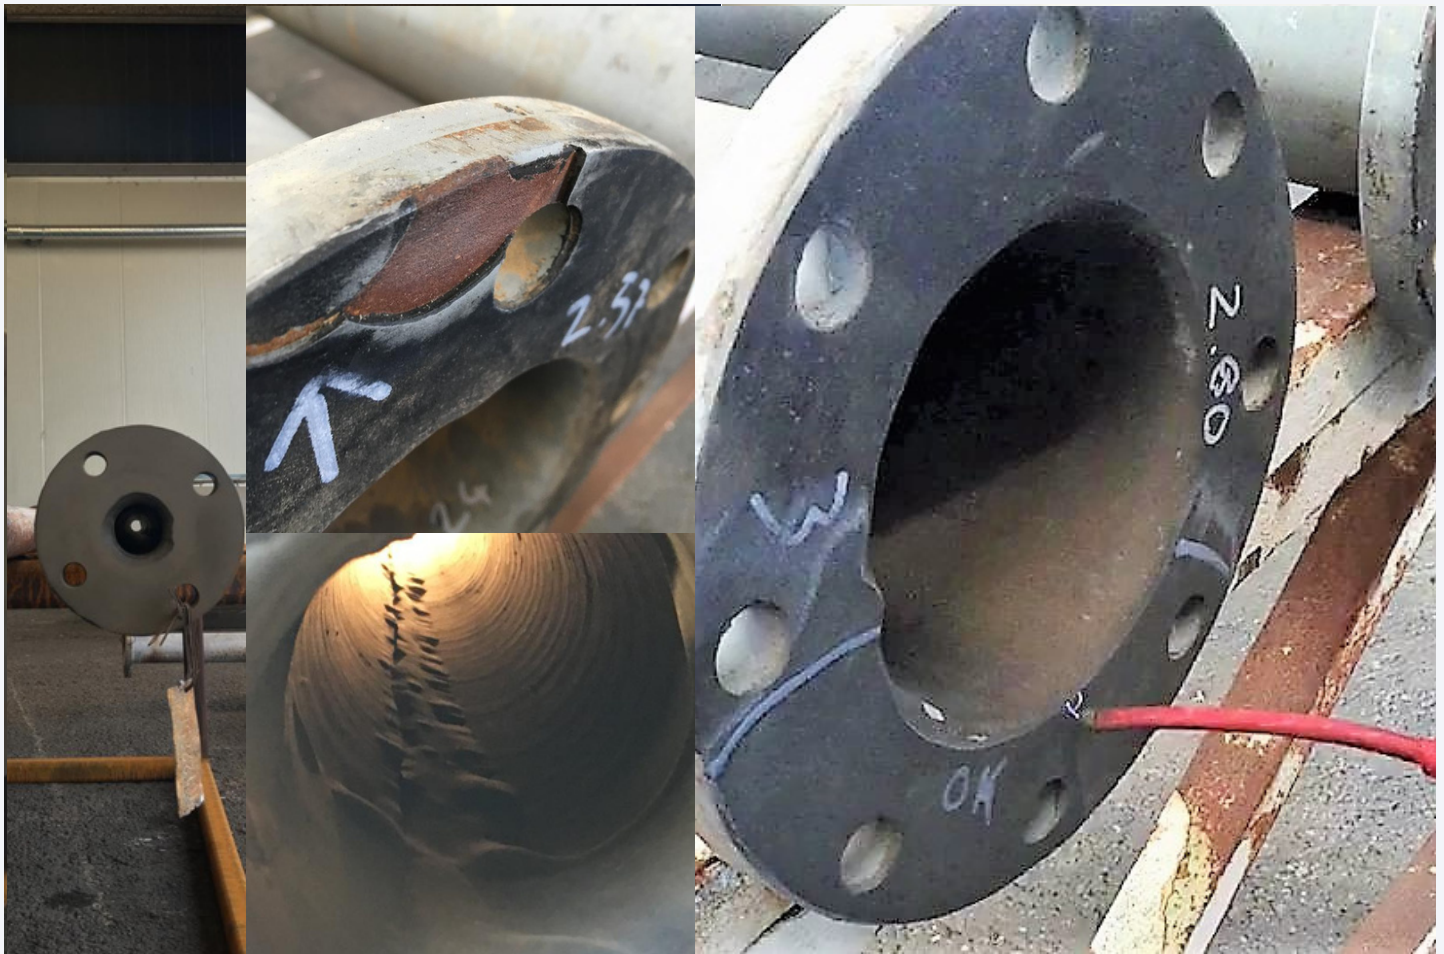
- Adhesion of the hard rubber on the pipes
  - Arising of several bubbles between the rubber lining and the pipe body
  - Conductivity of the rubber lined surface & failure of the spark test
-
